HOME INSPECTION REPORT

155 Rhodes Ave

Toronto

Inspection Date: [April 24 2025](#)

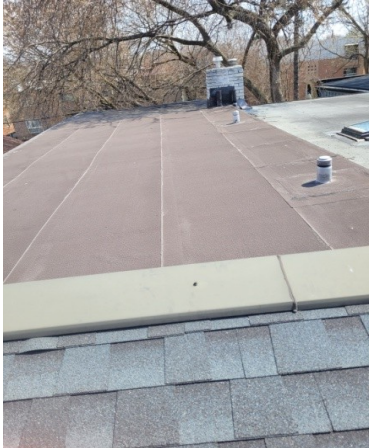
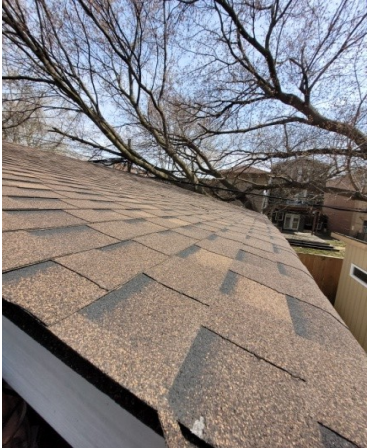
REFERENCE LINK		http://redbrickinspections.ca/docs/2_Roofing_Reference_Guide.pdf		
155 Rhodes Ave		ROOFING/Chimneys		April 24 2025
Description				
Roofing Material:	Location:	Leakage Probability:	Chimney(s) Type:	Location:
Asphalt Shingles:	Slope:	Low	Brick Shared:	Southeast
Modified Bitumen:	Flat:	Medium		
Asphalt Shingles:	Garage:	Low		
Limitations				
Roof Inspected By:	Access Limited By:	Chimney Access Limited By:		
From Edge Walking On	Height			
Observations/Recommendations				
<p>Tree Branches: retain arbourist for annual monitoring/trimming</p> <p>Sloped Surface: overall surface in good repair</p> <p>Porch(s): overall surface in good repair</p> <p>Flat Surface: overall surface in good repair, patched in some areas - continue to service</p> <div style="display: flex; justify-content: space-around;">

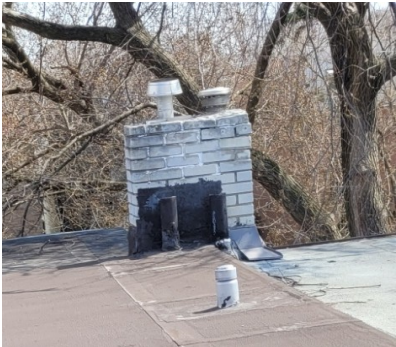
</div> <p>Chimney: overall in good repair</p> <p>Flashings: chimney/stack - patched- monitor/service</p> <div style="text-align: center;">

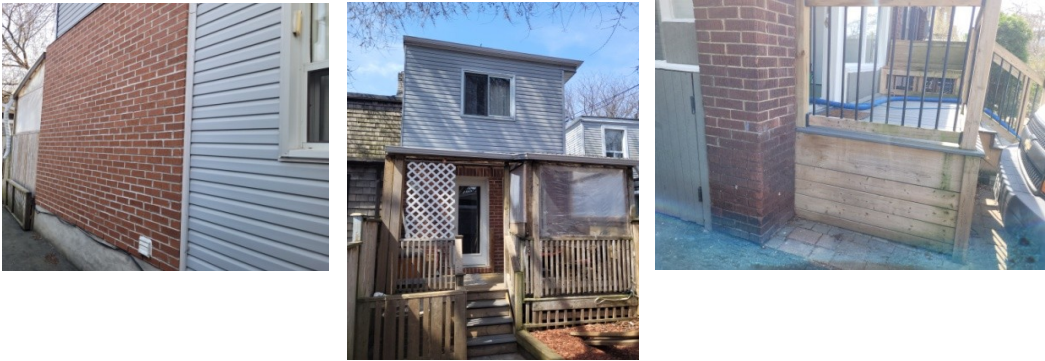
REFERENCE LINK		http://redbrickinspections.ca/docs/3_Exterior_Reference_Guide.pdf	
155 Rhodes Ave		EXTERIOR	
		April 24 2025	
Description			
Gutters & Downspouts: Aluminum:	Downspout(s) Discharge: Various Above Grade	Lot Topography: Flat	Walls & Wall Structures: Brick Asphalt Shingles Wood siding
Limitations			
Exterior Inspection from Ground Level		Restricted Access Under Porch(es)	
Restricted Access Under Deck(s)		Storage in Garage	
Observations/Recommendations			
<p>**Gutters/Downspouts: requires maintenance/cleaning</p> <p>WALL SURFACES:</p> <p>Brick: overall in good repair</p> <p>Vinyl Siding: overall in good repair</p> <p>Wood Shingles: aging - monitor/repair as required</p> <p>PORCH overall in good repair</p> <p>DECK overall in good repair</p>

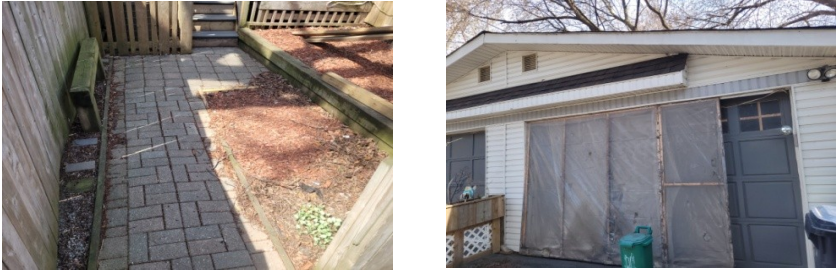
<p>**Walk(s): rear: low areas - re-grade if water pooling</p> <p>DETACHED GARAGE: overall well built</p>

<p>Note: Maintain Gutters & Downspouts annually. Extend Downspouts at least 6-feet away from the house</p> <p>** Any or all these items may contribute to Basement Leakage. Please see Interior Page</p>

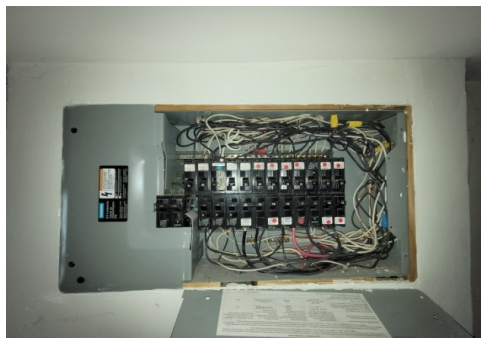
Limitations**Main Disconnect Cover Not Removed****Observations/Recommendations**SERVICE ENTRANCE: **overall in good repair**SERVICE PANEL: **overall in good repair**

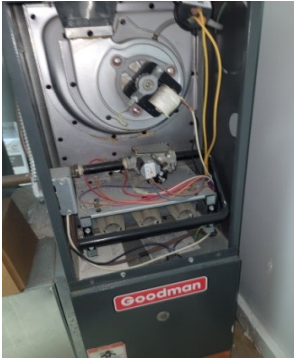
REFERENCE LINK		http://redbrickinspections.ca/docs/6_Heating_Reference_Guide.pdf			
155 Rhodes Ave		HEATING		April 24 2025	
Description					
Description:	Efficiency:	Rated Input:	Approx. Age:	Life Expectancy:	Fuel Type: Shut Off at:
Forced Air Furnace:	Mid	70 x1000BTU/hr	20 yrs.	20+ yrs.	Gas Meter-Interior
Exhaust Vent Arrangement: Metal Through Masonry Chimney					
Limitations					
Heat Loss Calculations Not Done					
Heat Exchanger- Inaccessible					
Observations/Recommendations					
<p>FORCED AIR FURNACE: service annually continue servicing until replacement becomes necessary</p> <p>Filter: replace 1-per-3 months</p>

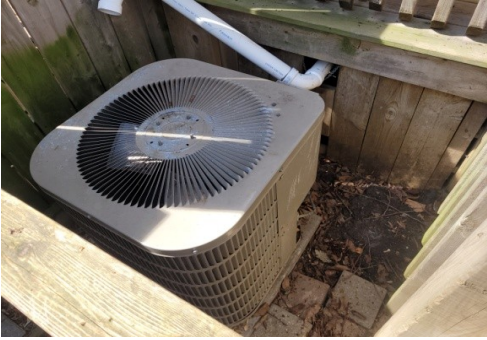
REFERENCE LINK	http://redbrickinspections.ca/docs/7_AC_Heat_Pump_Reference_Guide.pdf		
155 Rhodes Ave	COOLING/Heat Pumps		April 24 2025
Description			
Description:	Cooling Capacity:	Approx. Age:	Typical Life Expectancy:
Air Conditioner (air-cooled):	18 x1,000 BTU/hr	20 yrs. old	15 to 20 yrs.
Limitations			Cooling Performance
			Supply Temp F:
			Return Temp F:
Observations/Recommendations			
<p>AIR CONDITIONER: not tested: should be serviced before using old unit, continue servicing until replacement becomes necessary</p>
