# HOME INSPECTION REPORT

39 Melbourne Ave

Toronto

Inspection Date: [June 25 2025](#)

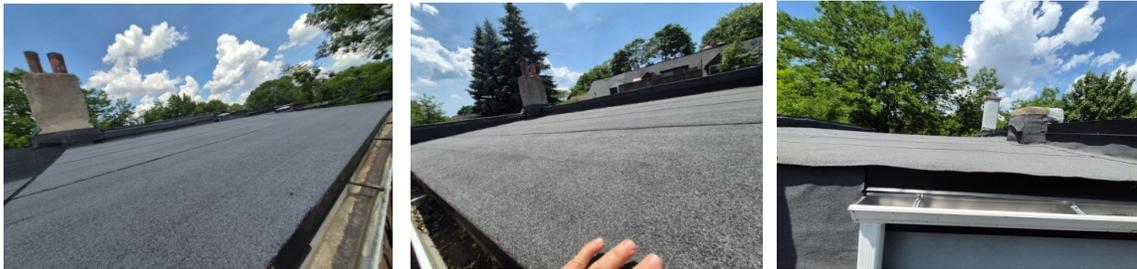
Flat Surface: [overall surface in good repair](#)

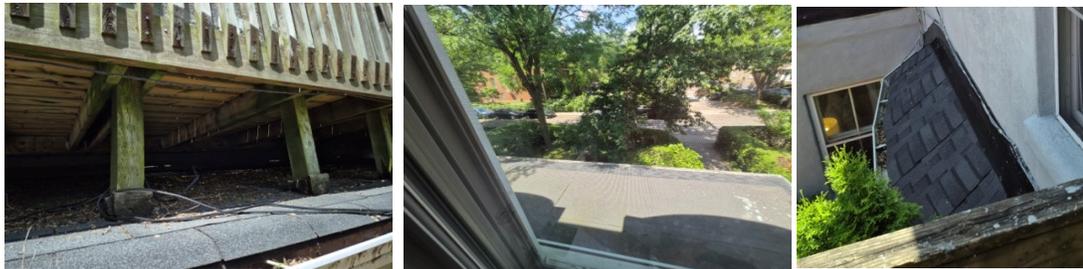
Bay(s): [overall surface in good repair](#)

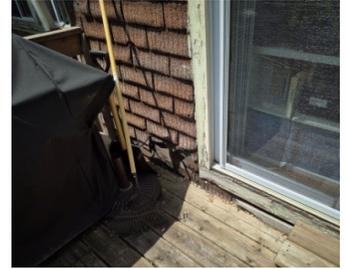
**PORCH(es):** overall in good repair

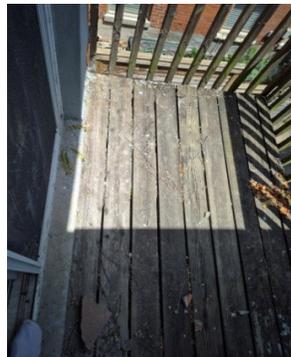
**DECK(s):** overall in good repair

monitor and repair upper deck floor boards as required

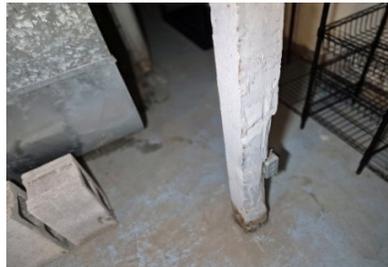
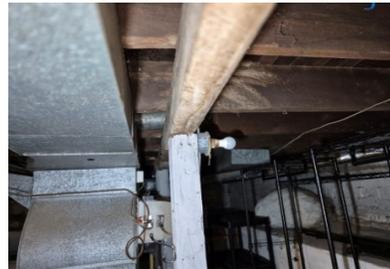
Wood Column: basement: installed with wood beam to shore up main floor, appears to be older installation though functional, monitor performance, bottom of column prone to rot - monitor, overall budget to re-place with engineered beam and column with proper footings

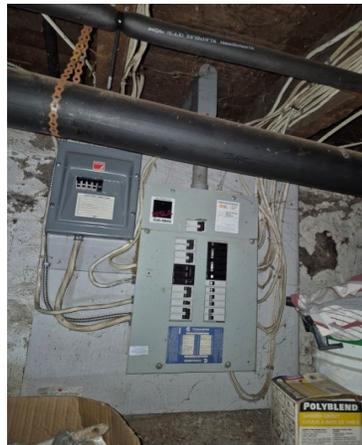
SERVICE ENTRANCE: overall in good repair  
 SERVICE PANEL: panel obstructed by cabinet - cover not removed  
 Auxiliary Panel: overall in good repair

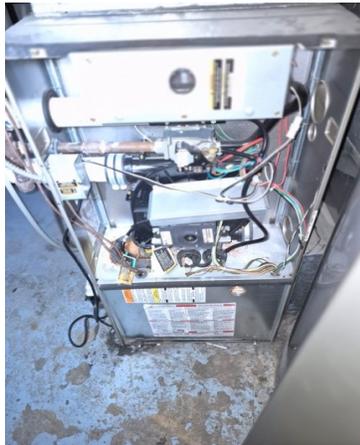
Exhaust Pipes: east exterior wall: should install collision barrier

FORCED AIR FURNACE: service annually  
recommend obtaining replacement parts/servicing contract  
Filter: replace 1-per-3 months

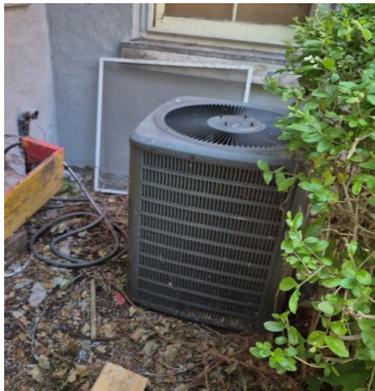
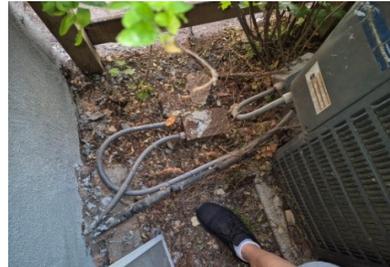
Outdoor Coil: [trim plants away, coil requires cleaning](#)  
[loose junction boxes- secure properly](#)
