HOME INSPECTION REPORT

83 Gwynne Ave
Toronto

Prepared by: Bob Papadopoulos P.Eng., RHI *

Inspection Date: [Aug 6 2025](#)

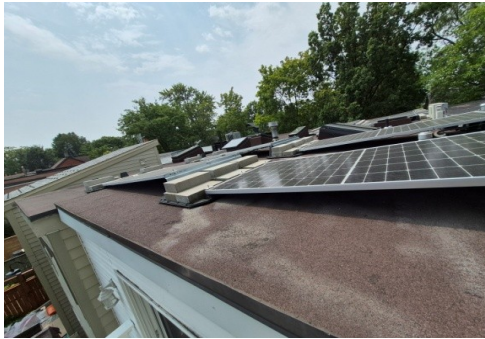
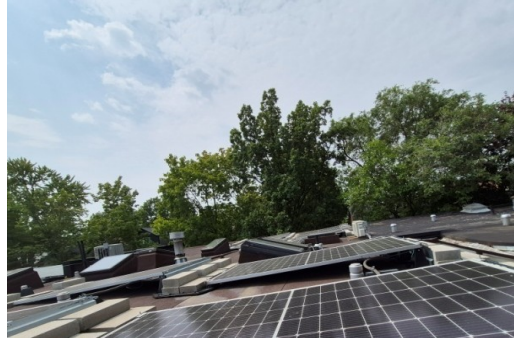
Flat Surface: [overall surface in good repair where visible \(solar panels\)](#)

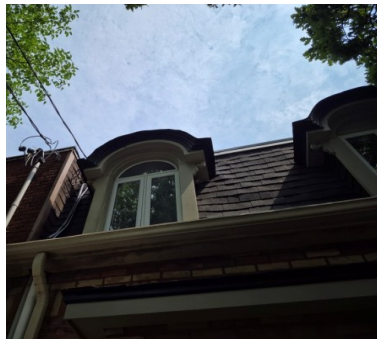
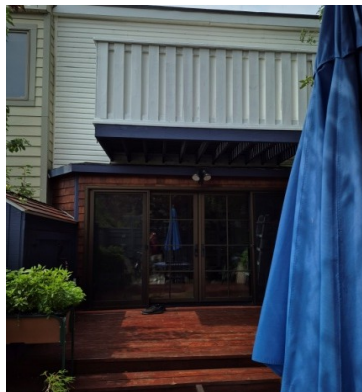
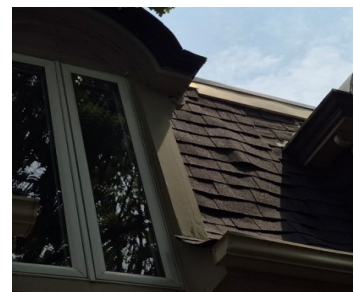
WALL SURFACES: overall in good repair
 Brick: prior abrasive cleaning - overall in good repair, monitor
 DOORS/WINDOWS: overall in good repair
 Soffit & Facia: wood components: maintain as required
 Asphalt Shingles: minor unevenness: monitor/repair as required

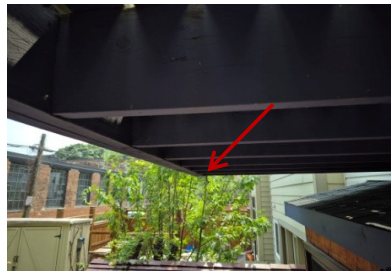
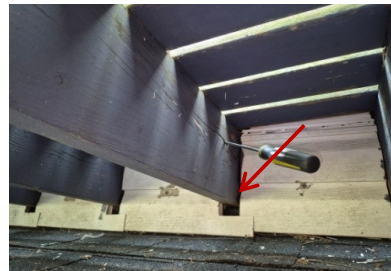
DECK overall in good repair
 PORCH rear upper: overall in good repair, joists - monitor and repair/reinforce if required, minor sagging noted - overall recommend installing columns to support structure, seal around wall penetration to minimize risk of moisture damage to joists

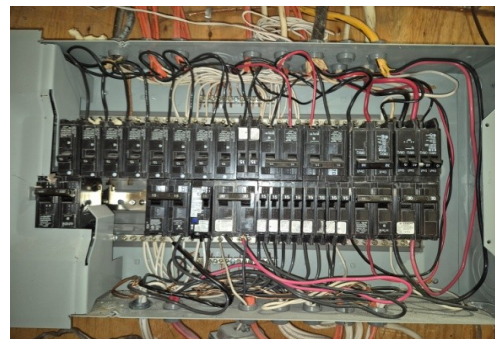
SERVICE PANEL: **overall in good repair**

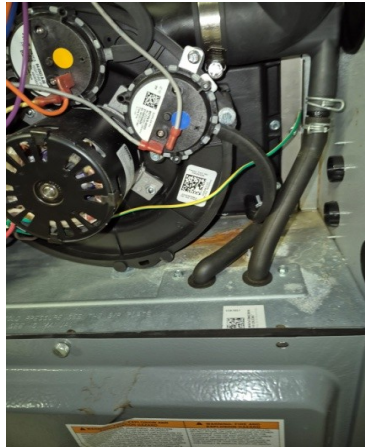
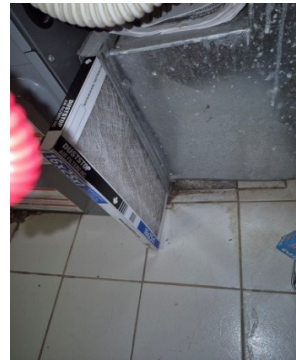
FORCED AIR FURNACE: service annually
minor rusting inside of cabinet

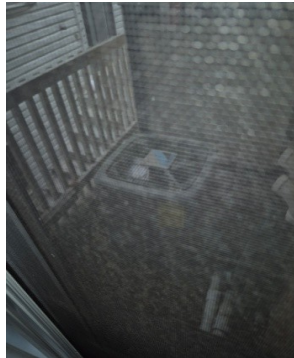
AIR CONDITIONER: [service annually](#)
 DUCTLESS A/C: [service annually](#)
 Outdoor Coil: [could not access at north wall and roof units](#)
