HOME INSPECTION REPORT

187 Indian Grove
Toronto

Prepared by: Bob Papadopoulos P.Eng., RHI *

Inspection Date: [Aug 27 2025](#)

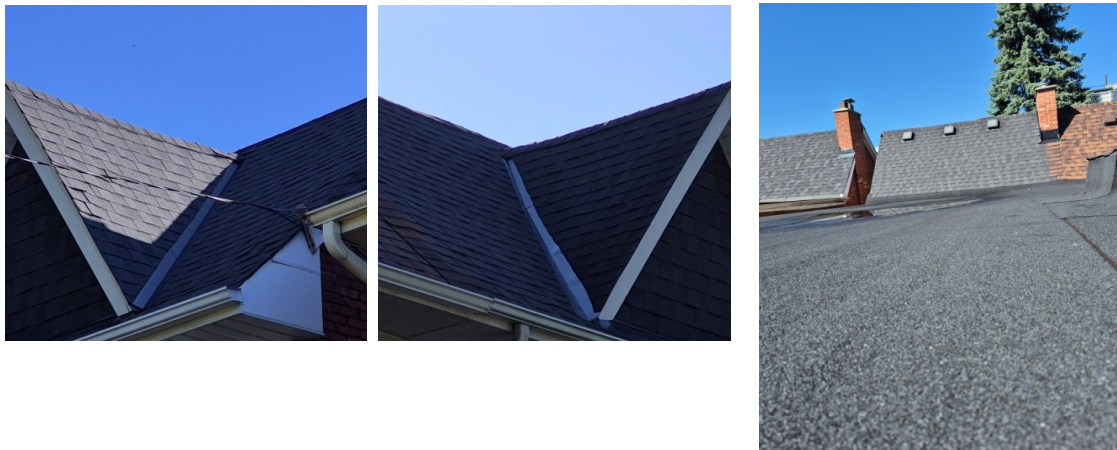
Sloped Surface: [overall surface in good repair](#)

Flat Surface: [overall surface in good repair, some water pooling noted though typical](#)

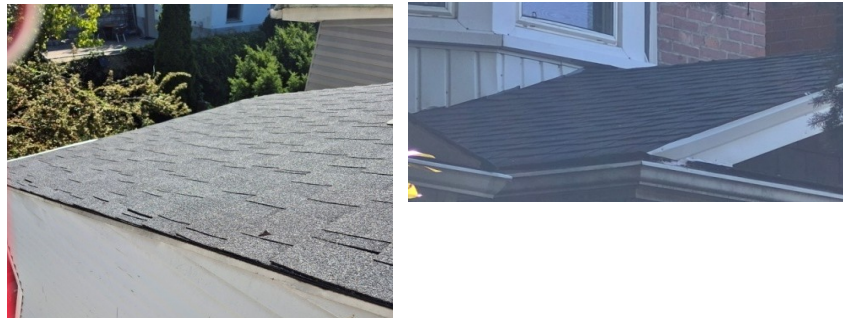
Sloped Surface: [overall surface in good repair](#)

Porch(s): [overall surface in good repair](#)

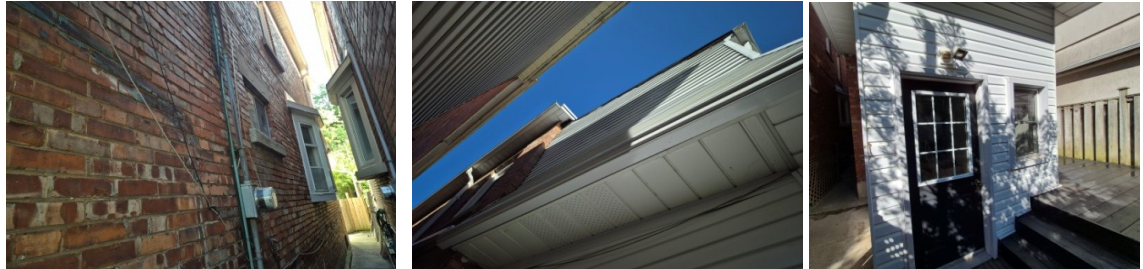
WALL SURFACES: overall in good repair
DOORS/WINDOWS: overall in good repair

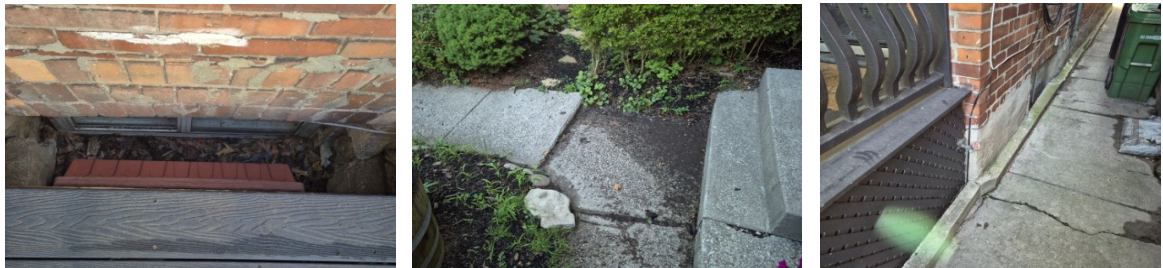
DECK overall in good repair
PORCH overall in good repair
**Window wells: provide window well covers
**Walk(s): uneven trip hazard - repair
repair cracks

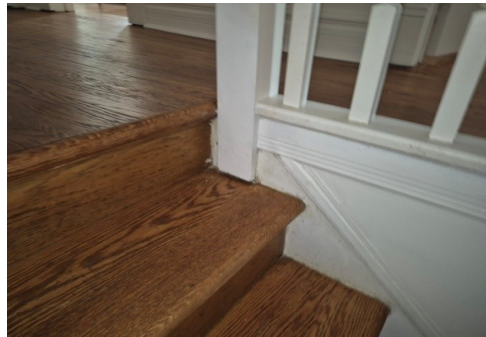
Stair Opening: minor sagging around stair areas though typical for older house

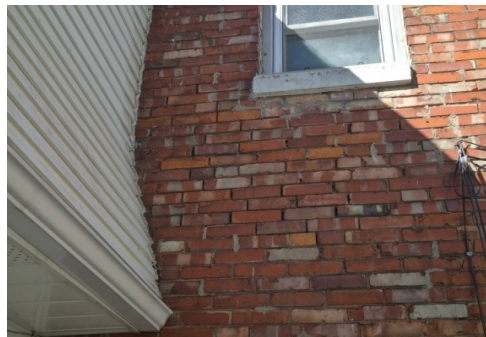
Masonry: repair mortar as required

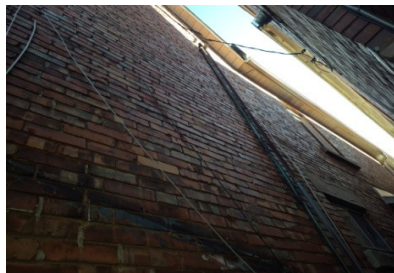
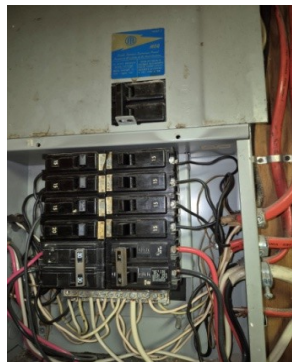
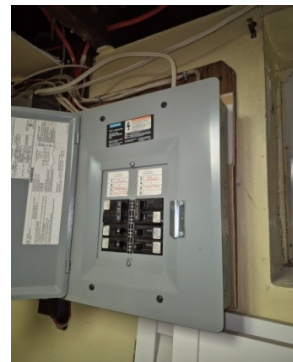
SERVICE ENTRANCE: older, overall in good repair, upgrade if renovating or upgrading wiring
 SERVICE PANEL: older, overall in good repair, upgrade if renovating or upgrading wiring
 Auxiliary Panel: overall in good repair

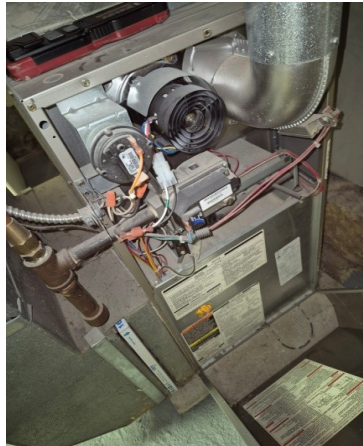
FORCED AIR FURNACE: [service annually, not tested - service before use](#)
[older, continue servicing until replacement becomes necessary](#)

Filter: [replace 1-per-3 months](#)

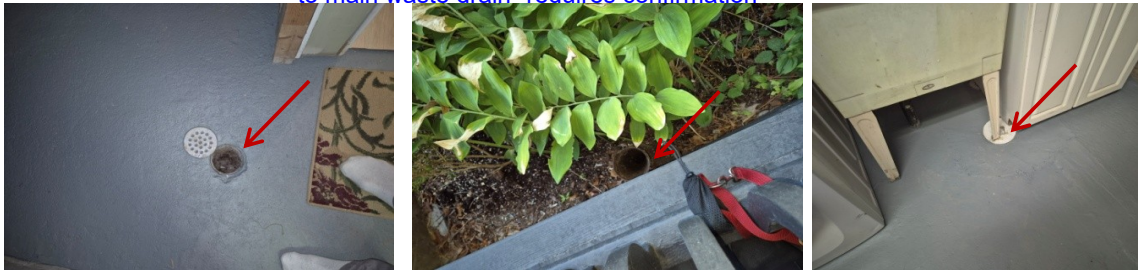
Floor Drain/Trap: requires service/cleaning/further evaluation

Piping: exterior front garden: old cleanout, cap missing - further evaluation - repair and suspect older main drain, recommend video-scan, risk of tree roots
basement front floor: appears back flow valve has been installed to main waste drain- requires confirmation
